Manhole Inspection Summary

Manhole # S39MM_047MH

Insp Date: **2/5/07 11:36 AM**

Location Address: **909 22ND ST**

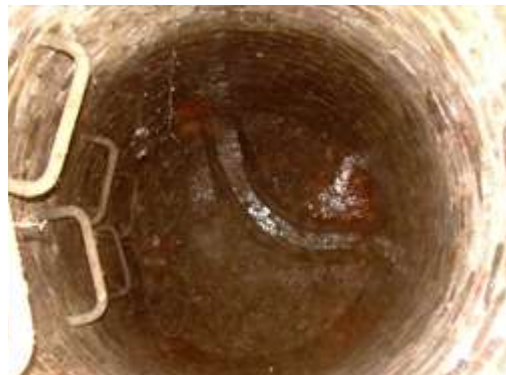
Top View

Evidence of surcharge - Bench debris.
Channel debris.

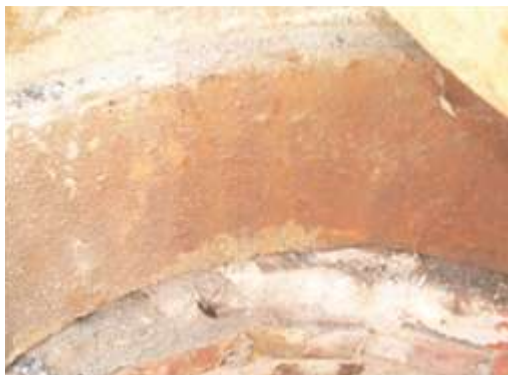
Defect

Frame Offset: **2** (in.) Condition: ☐ Sound ☐ Cracked ☒ **Leaks**

Frame leaks. Frame offset.

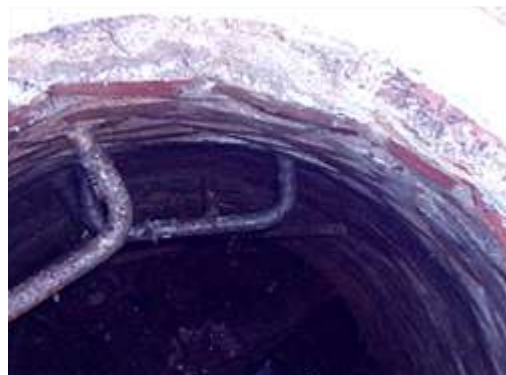
Defect

Frame offset.

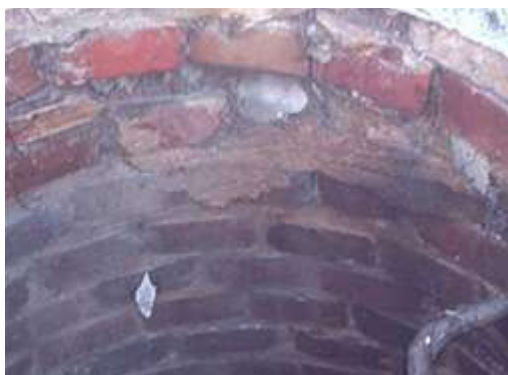
Defect

Chimney / Frame Adjustment ☒ Exists Material: **Brick** ☐ Parged Height: **6** (in.)
Condition: ☐ Sound ☐ Cracked ☐ Root Intrusion ☐ Loose Brick ☒ **Deteriorated**
Infiltration: ☐ None ☒ **Joint** ☐ Cracks ☐ Mortar ☐ Roots ☐ Wall

Adjustment deterioration and infiltration.

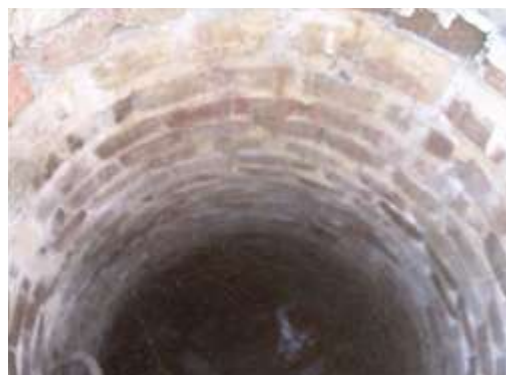
Defect

Barrel Material: **Brick** ☐ Parged
Shape: **Circular** Diameter: **46** (in.) Length: (in.)
Condition: ☒ Sound ☐ Cracked ☐ Root Intrusion ☐ Loose Brick ☐ Deteriorated
Infiltration: ☐ None ☐ Joint ☐ Cracks ☒ **Mortar** ☐ Roots ☒ **Wall**

Adjustment deterioration and infiltration.
Barrel infiltration.
